Manhole Inspection Summary

Manhole # S03UU1004MH

Insp Date: **9/21/06 1:24 PM**

Location Address: **3618 Glen Ave**

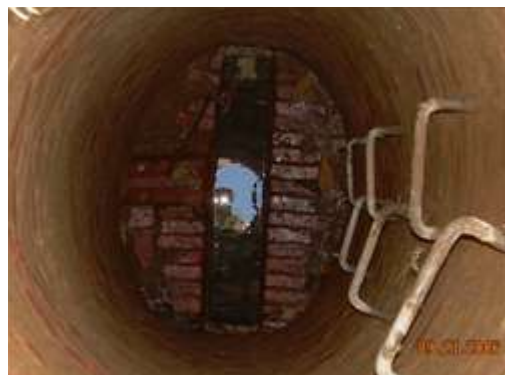
Top View

Adjustment, Corbel and Barrel infiltration.
Corroded steps. Evidence of surcharge -
Bench debris. Channel debris.

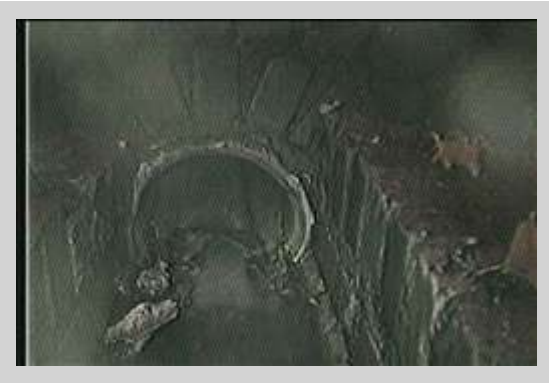
8 in. Circular Gravity Sewer Pipe Out @ 12 O'Clock

Infiltration: **Evidence** Pipe Seal Cond: **Unknown**

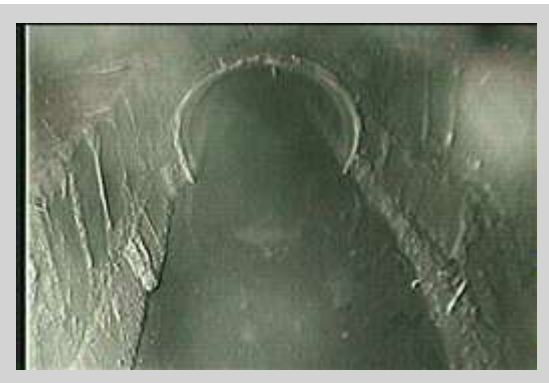
8 in. Circular Gravity Sewer Pipe In @ 6 O'Clock

Channel deterioration.

Infiltration: **Evidence** Pipe Seal Cond: **Unknown**
